THE SEVENTH REGIMENT ARMORY ON PARK AVENUE

ENVIRONMENTAL CONDITIONS DOCUMENT REVIEW

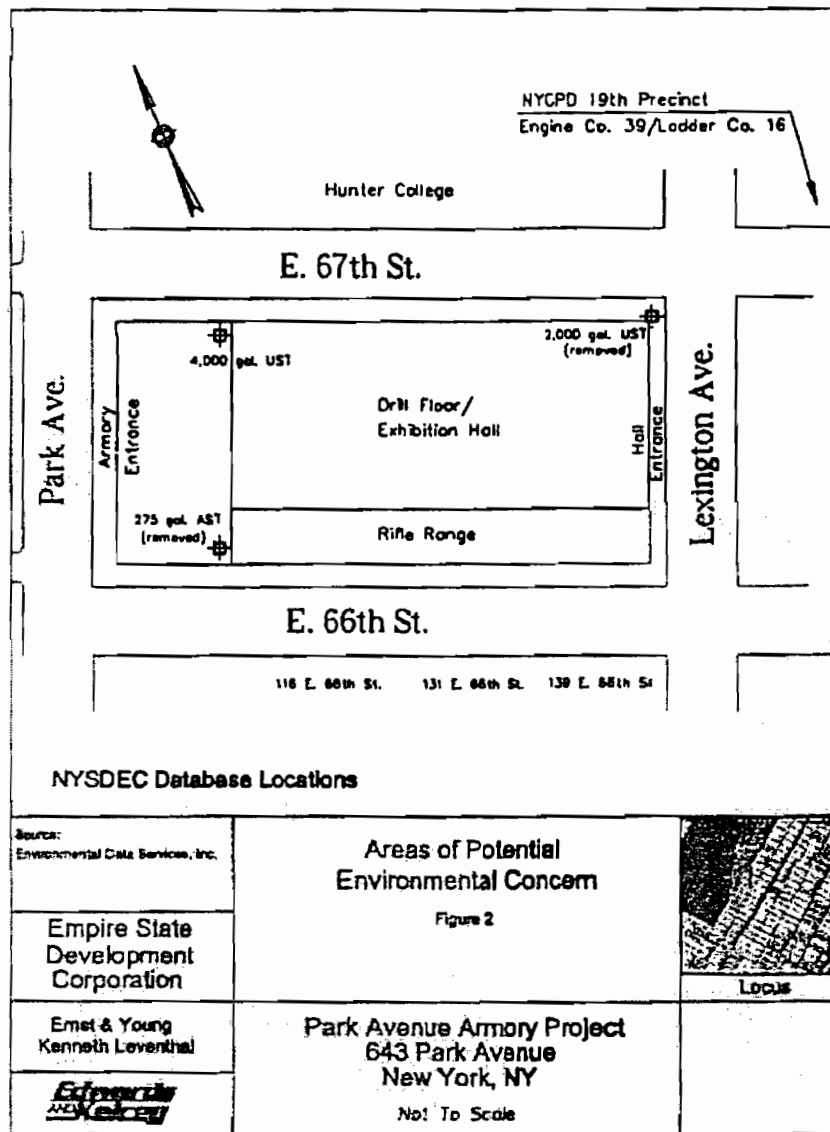
Three tanks are listed at the project site on the NYSDEC Petroleum Bulk Storage (PBS) Underground Storage Tank (UST) and Aboveground Storage Tank (AST) lists. The relative location of these tanks is presented in Figure 2 below.

The NYSDEC PBS Database identified 45 USTs within ¼ mile of the project site. Most USTs are located within apartment buildings in this predominantly residential neighborhood. As indicated in Table 1, of the eight USTs located within 1/8 mile of the project site, five are tanks in apartment buildings (ranging in capacity from 5,000 to 20,000 gallons). Diesel and unleaded gasoline tanks (including both USTs and ASTs) are located at the NYCPD 19th Precinct at 153 E/ 67th Street, Engine Co. 39/Ladder Co. 16 at 157 East 67th Street, and Hunter College at 695 Park Avenue. Locations of adjacent tanks are indicated in Figure 2.
